**DECKER'S MARINE SURVEYING SERVICES**  
MARINE SURVEYORS AND CONSULTANTS

**1982 33' Mirage Sailing Sloop**

***Mamashee***

# **Report of Marine Survey**

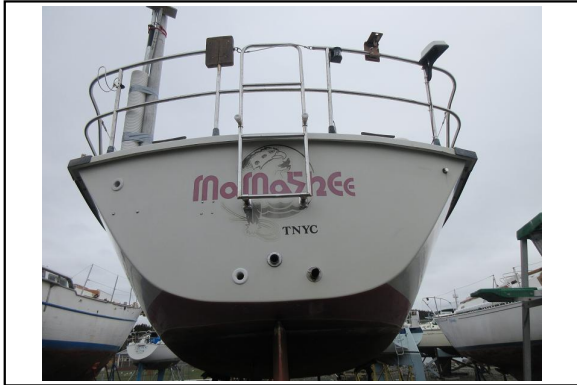
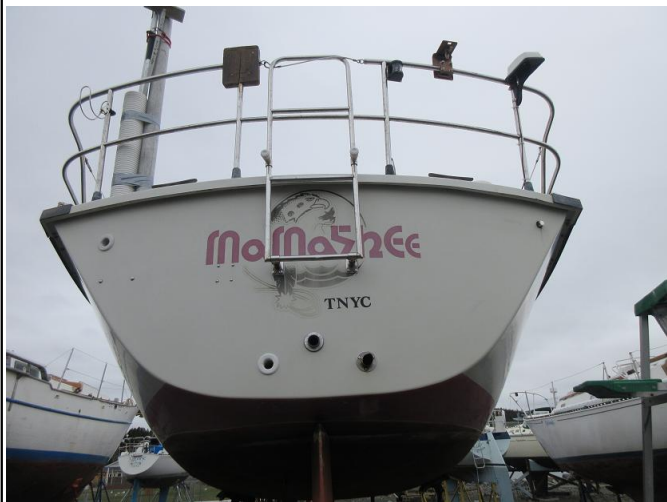
**Transom**

**TRANSOM:** Vessel carries her beam well aft with a flat transom, fitted with stainless steel boarding ladder, and name attached. Serviceable.

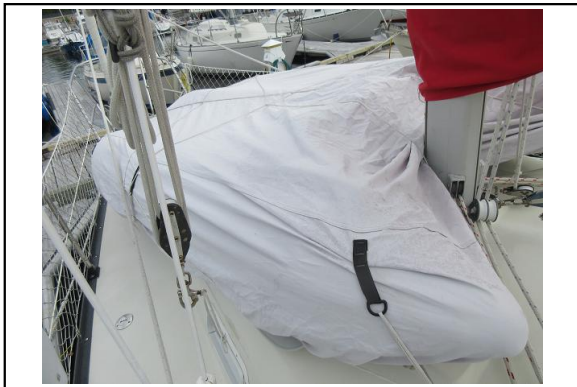
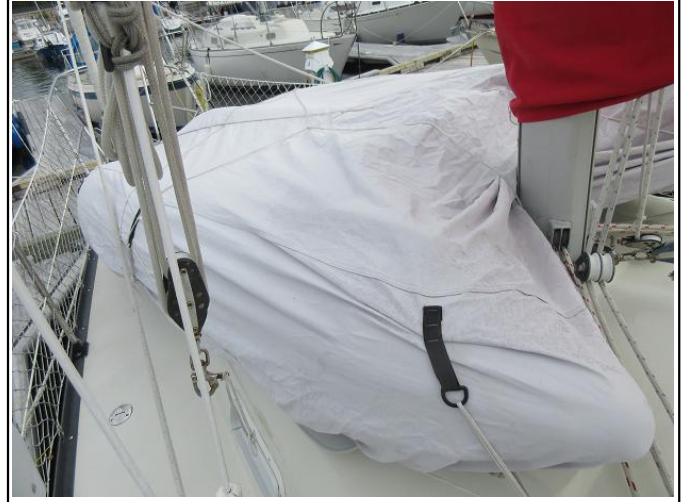
Dinghy

**DINGY/TENDERS:** Vessel carries 10' Aqua Marine Dinghy, model 300, ISO # 6185-22001, serial # CN-HA3023093 and is stored on deck with canvas cover. Good condition.

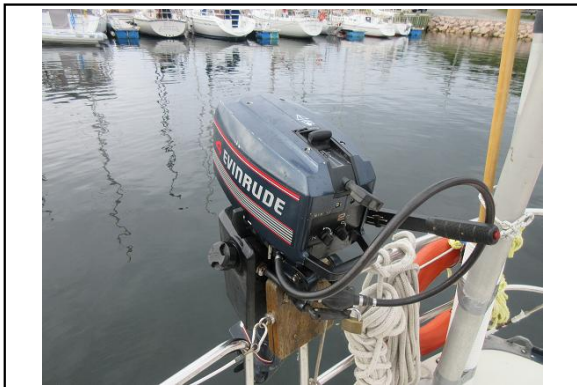
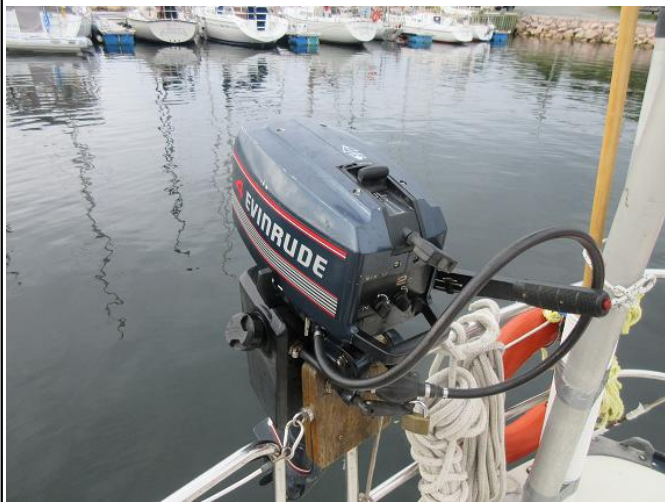
Outboard Motor

**AUXILIARY MOTORS:** The dinghy is fitted with an Evenrude 4 horse power outboard motor, model # CE4RESR, serial # C2463229, and is stored on the aft pulpit with bracket and cover.

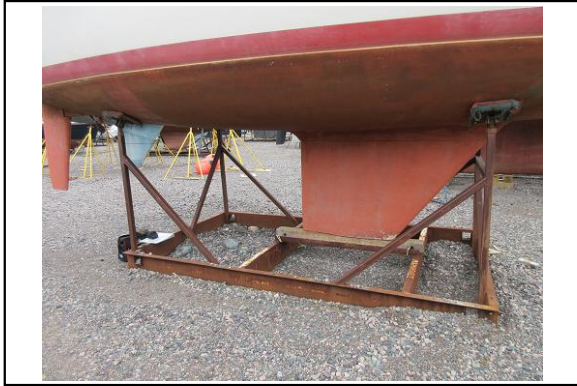
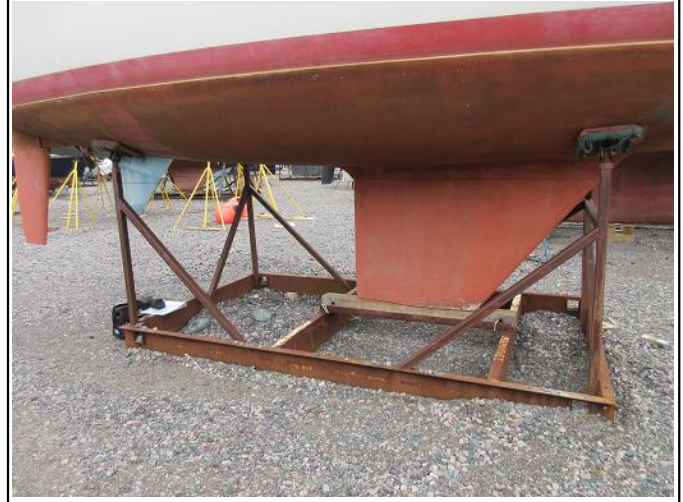
**Steel Cradle**

**OTHER:** When the vessel is on the hard she is stored on a steel cradle with four (4) pads. Good condition.

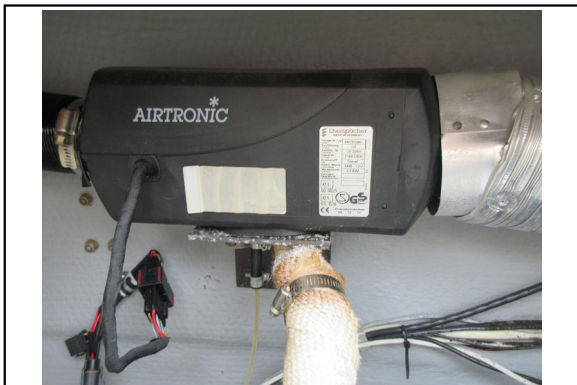
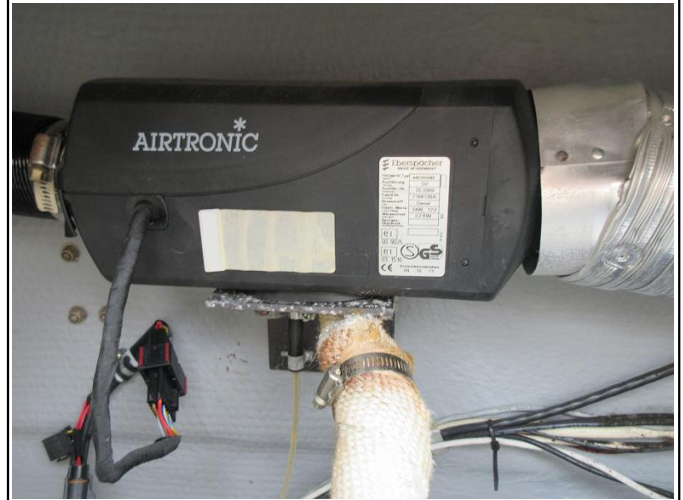
**Espar Heater**

**OTHER:** Vessel with a Espar Airtronic Diesel D2 forced air cabin heater. Tested and confirmed its operation.

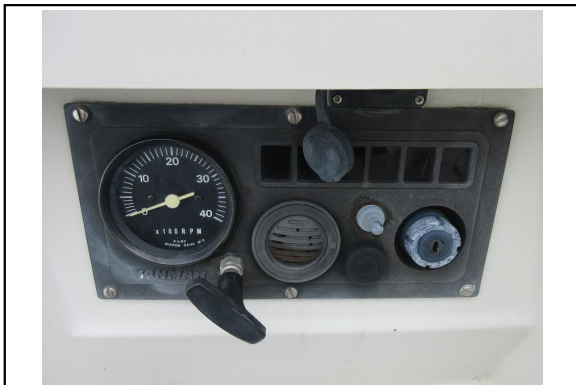
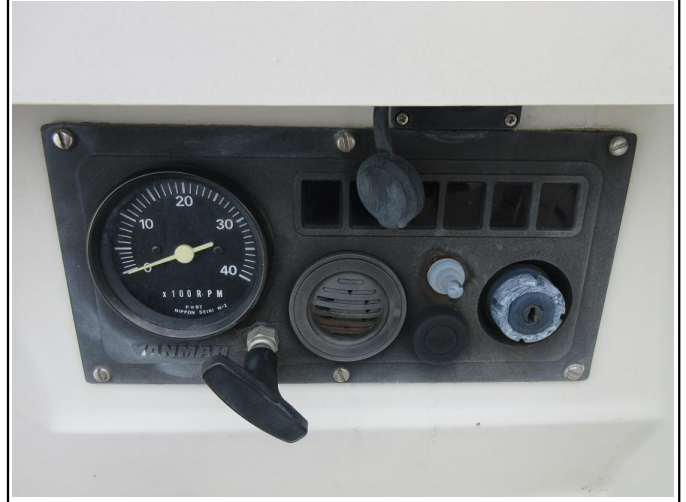
Engine Gauges

**TYPE/MANUFACTURER/LOCATION:** Vessel fitted with naturally aspirated Yanmar Marine Diesel Engine, model # 3GM20D, serial # 03792, 20 horse power, three (3) cylinder, operating hours unknown, max RPM's 3400. Engine appears to be in good condition with little corrosion for the age of the vessel. Engine was started at the dock and ran for approximately 5 minutes under load and reached maximum RPM of 3000. There was some blue smoke evident when operating maximum RPM, but engine appears to be working well. Serviceable.

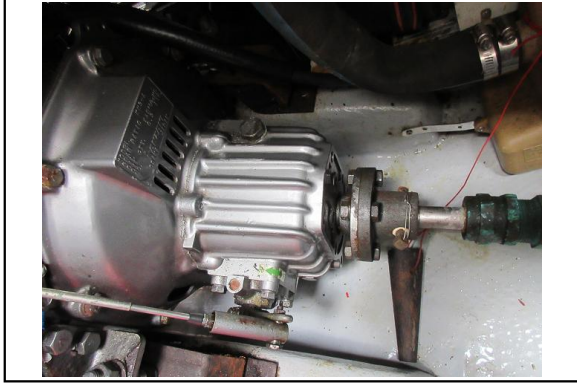
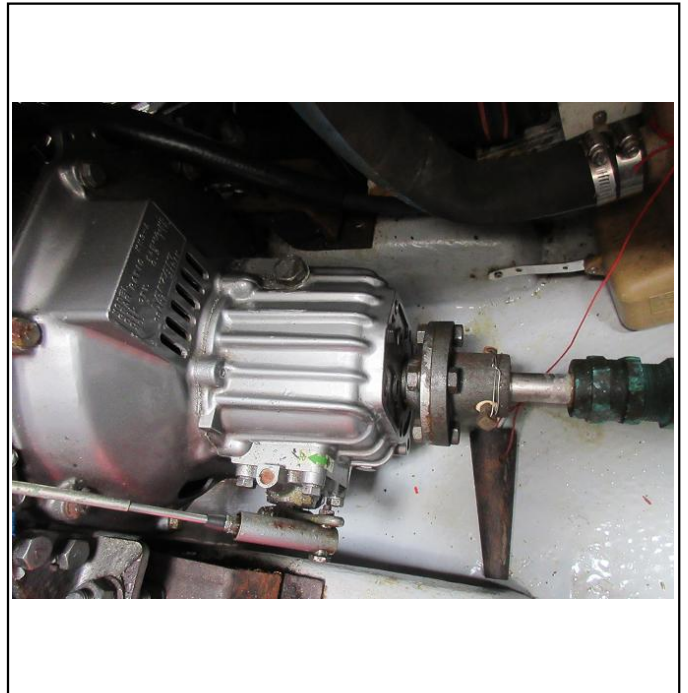
**Transmission**

**TRANSMISSION:** Yanmar Kanzaki Transmission, model # KM3-A. Operating as fitted.

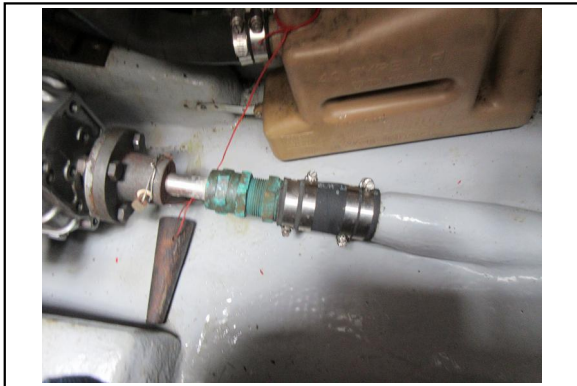
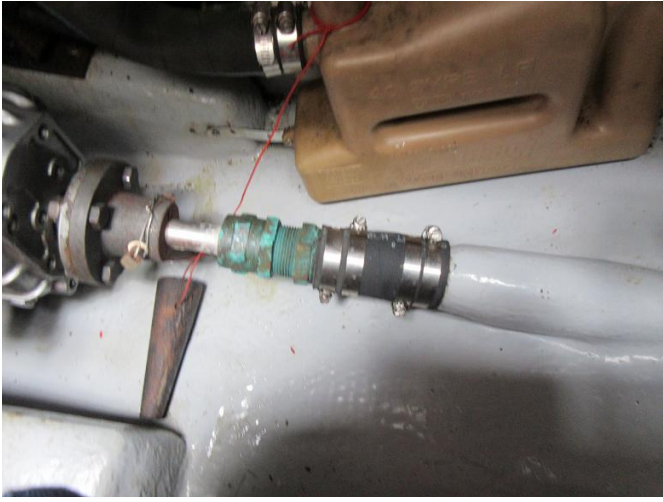
**Stuffing Box**

**PACKING GLAND:** Double clamped and appear to be in good condition.

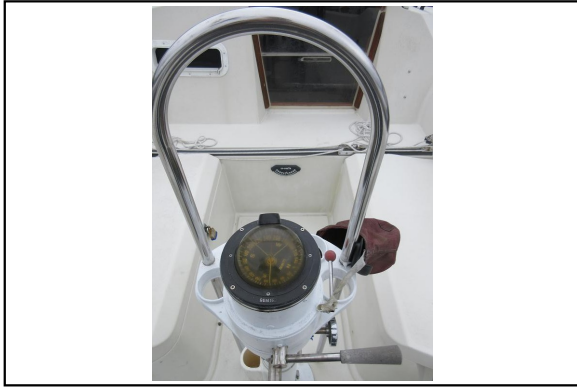
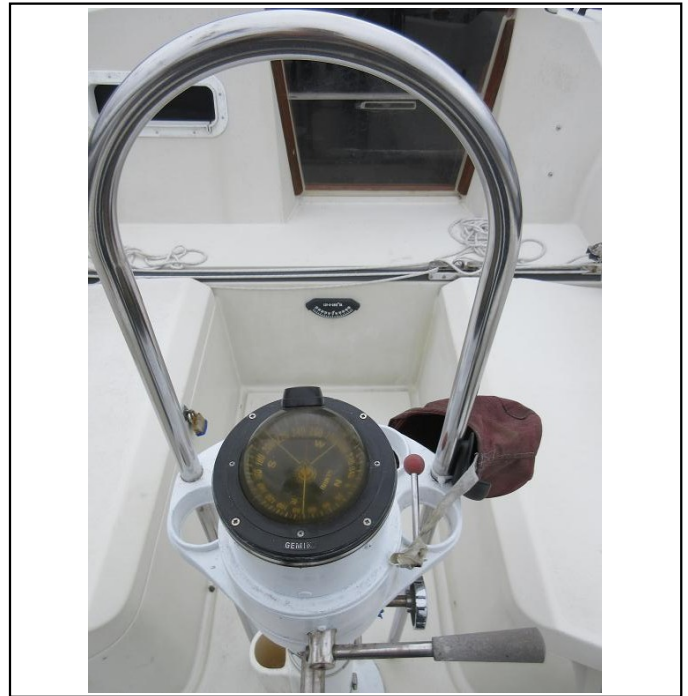
Binnacle

**TYPE/MANUFACTURE:** Edson pedestal fitted with cable and quadrant. The cables are tight with no signs of corrosion. The rudderstock is 2 1/2" stainless steel and the wheel is stainless steel 36" covered with leather. Good condition.

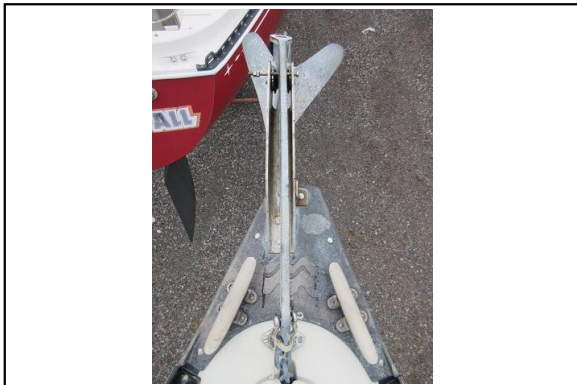
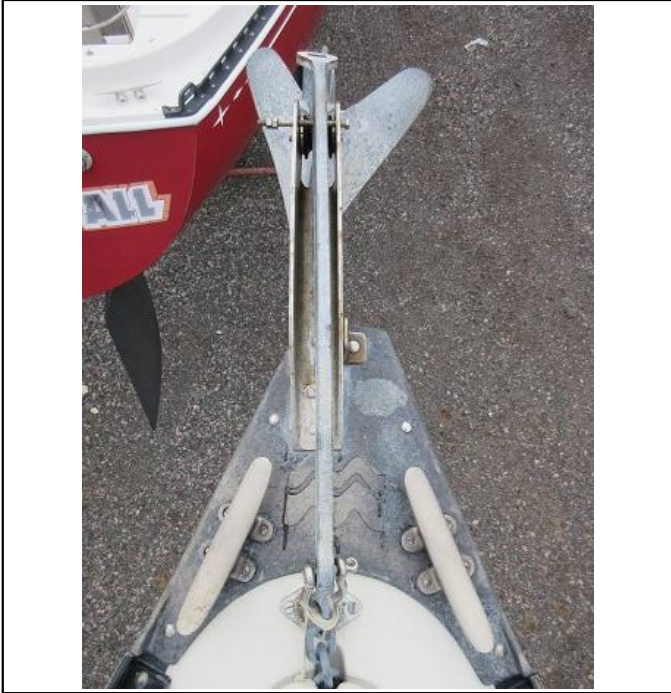
Anchor Arrangement

**ANCHORS:** Vessel fitted with a 25 pound Hinged-Plow Dickenson Anchor and has 20' of 1/4" galvanized chain and 200' of 3/4" nylon rope. Vessel also carries a spare rode system that consist of a 20 pound Bruce Anchor with 15' of 1/4" chain and 100' of nylon rope. Rode system more than adequate for the size of vessel.

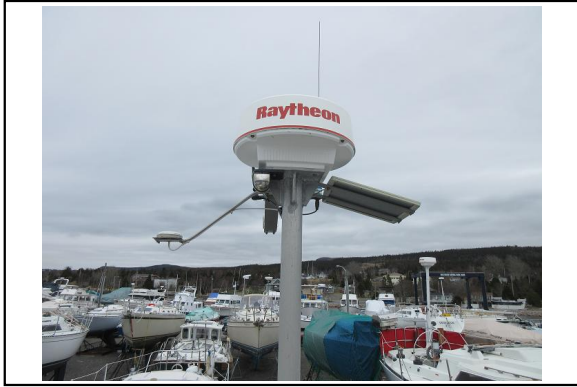
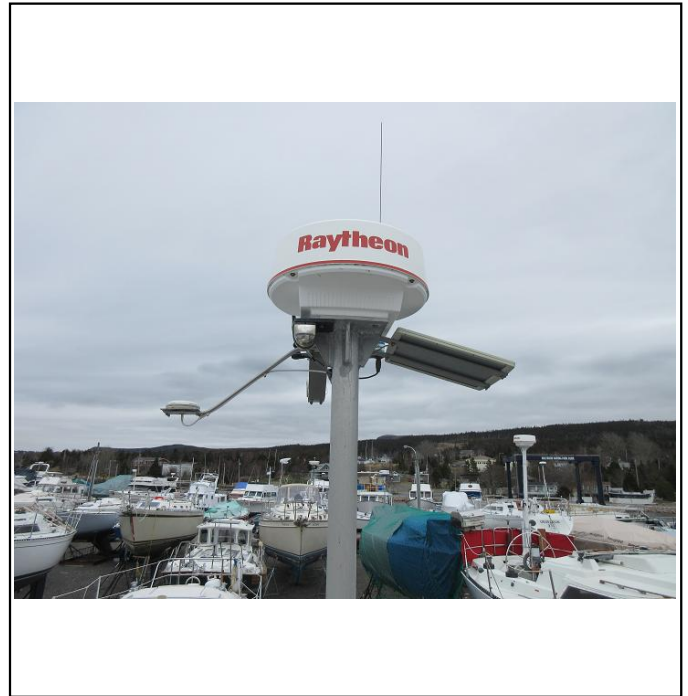
**Radar Dome Post**

**RADAR:** Raytheon Radar, model # R10 Rastar Scan, serial # LE23562. Powered up and operated.

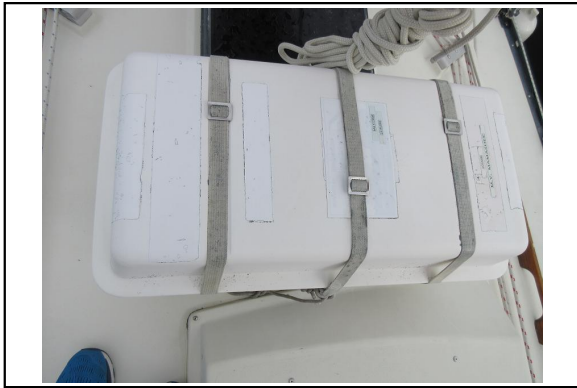
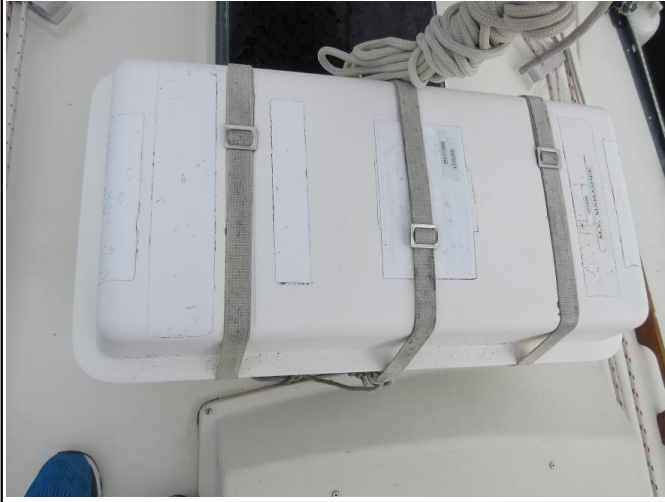
Liferaft

\* **LIFE RAFT: [B1]** Vessel carries a Viking 4 person Life raft located in a cradle on the cabin top just forward of the dodger, serial # J010296, last serviced May 2008.

**The 4 person liferaft carried on this vessel was last serviced in May 2008. This vessel is up for sale and it's strongly recommended that the new owner have it serviced or removed from the vessel.**

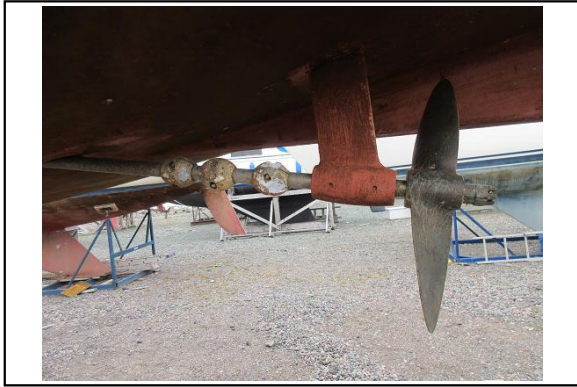
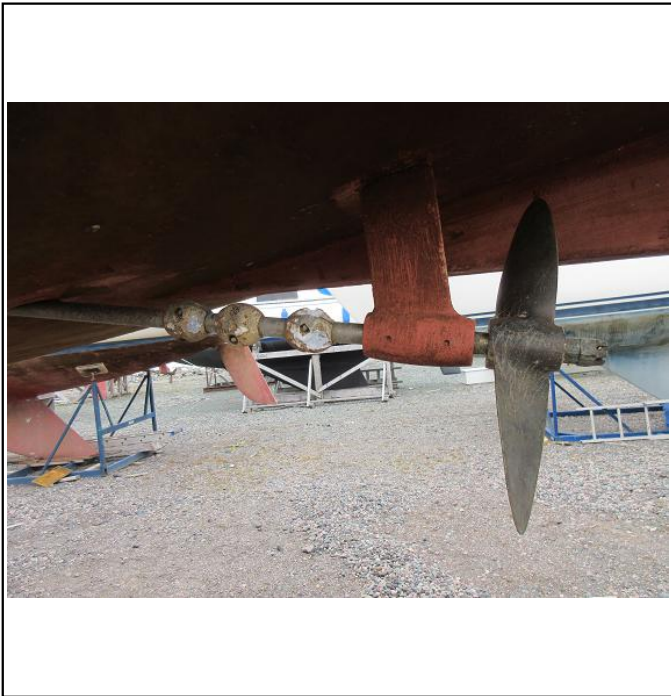
Shaft & Propeller

**PROPELLER(S):** Vessel fitted with a Sailer 14" RH, two blade, bronze propeller, fitted to a 7/8" stainless steel shaft. Serviceable.

**SHAFT BEARING (CUTLASS BEARING):** Cutlass bearing showed no signs of sloppiness or end play. There was minor cracking in the gelcoat in way of the shaft and strut. Hammered and it appears to be solid and owner advised to inspect yearly.

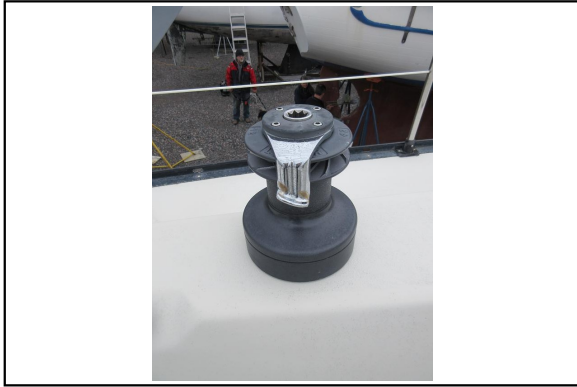
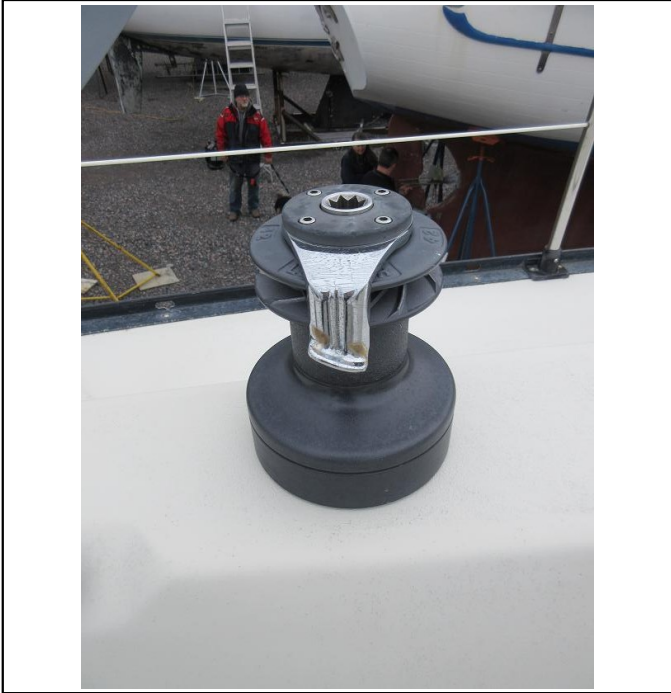
**Primary Winch**

**WINCHES:** Vessel fitted with Lewmar Primary self tailing winches #40, port and starboard side and on the cabin top are Lewmar self tailing winches #8, port and starboard. Good condition.

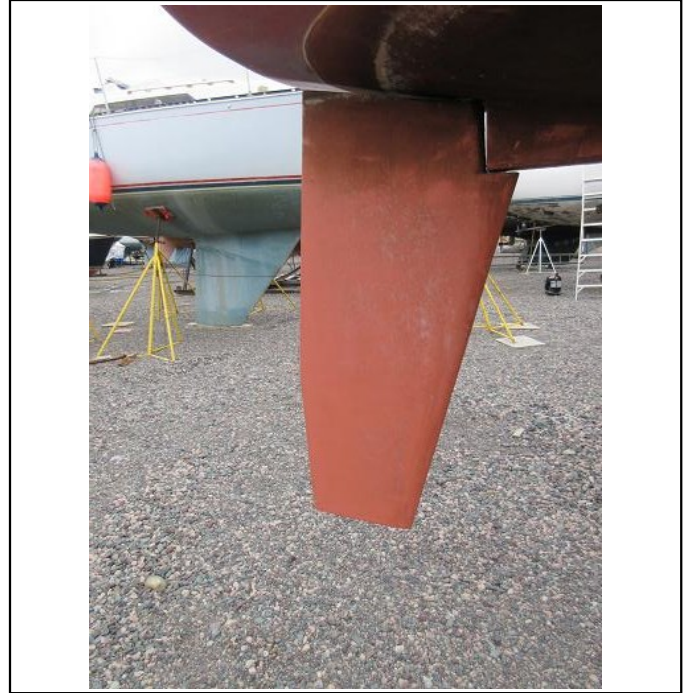
**Rudder**

**RUDDER(S) MATERIAL:** Rudder is constructed from FRP with a 2 1/2" stainless steel stock. The rudder was hammered and the moisture meter used with good results and there was not indication of cracking anywhere on the rudder. Serviceable.

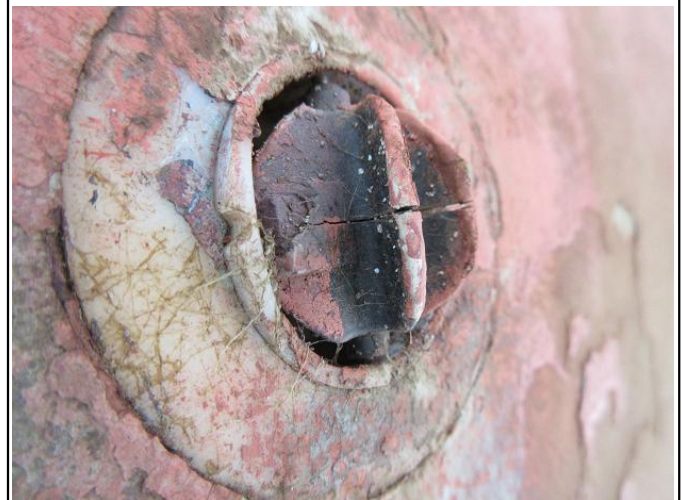
**Speed Log**

**SPEEDLOG:** Raymarine Speed Log. One of the impellers broken and therefore not providing accurate information. Powered up.
