**DECKER'S MARINE SURVEYING SERVICES**  
MARINE SURVEYORS AND CONSULTANTS

**1982 33' Mirage Sailing Sloop**

***Mamashee***

# **Report of Marine Survey**

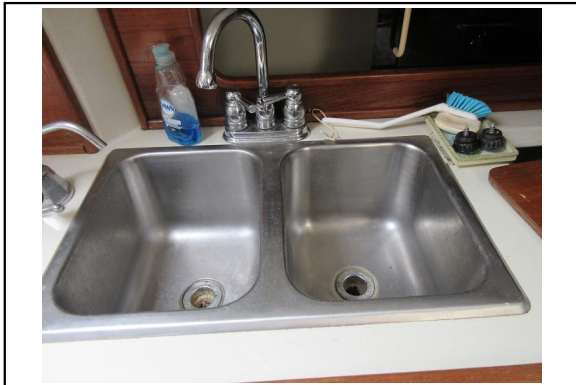
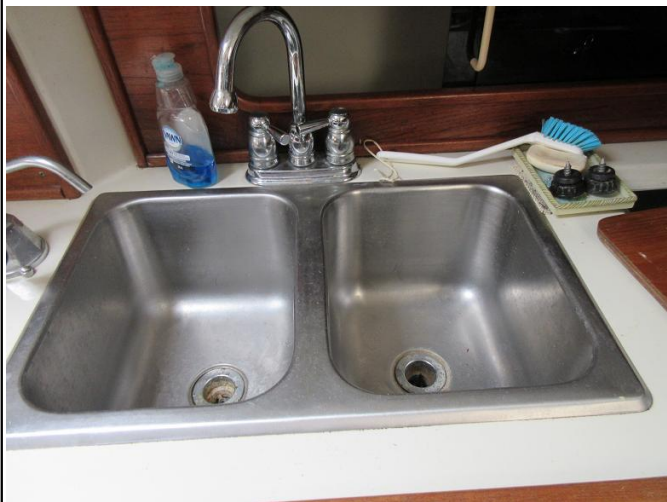
Galley Sink

- Double stainless steel sink
- Pressure water
- HilleRange LPG, two burners plus oven gimble stove
- Large ice box, fitted with electric pump
- Hot and cold shower located in the cockpit
- Stainless Steel Dickenson BBQ with cover and securing bracket
- Folding cockpit wooden table

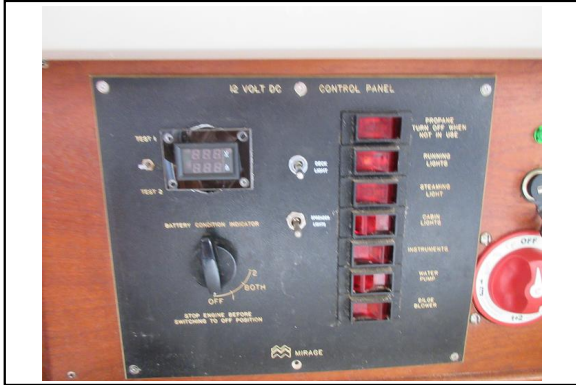
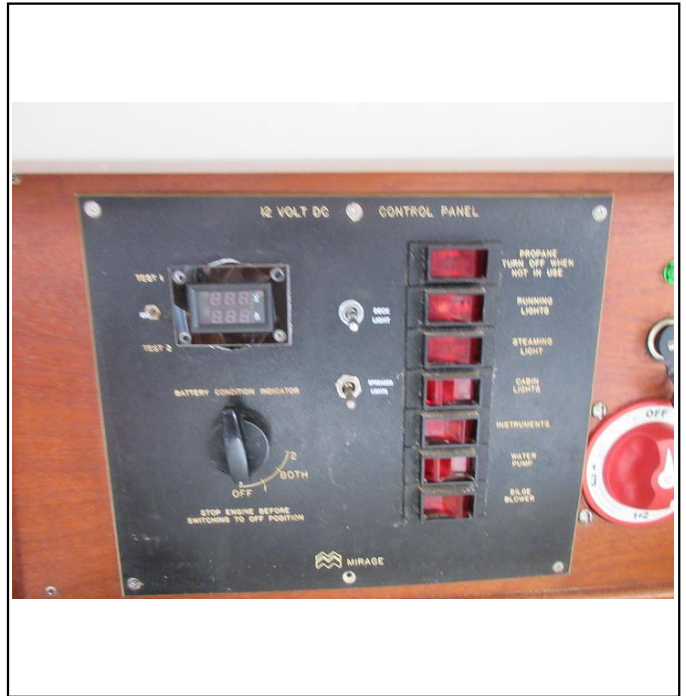
**VOLTAGE/BATTERIES:** Vessel fitted with DC 12 volt power system and has three (3) batteries, one starting battery and two deep cycle house batteries with the option of using the house batteries one at a time or both. There are two Blue Sea Main Battery Switches, there is a DC panel for the house system and another DC Panel mainly used for Navigation System.

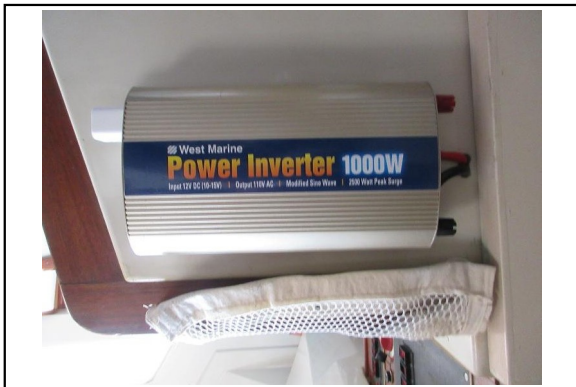
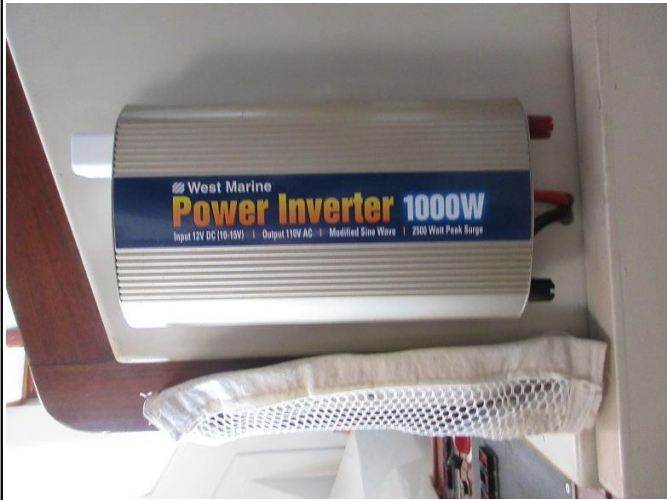
**INVERTER:** Vessel fitted with a West Marine Power Inverter 1000 watts.

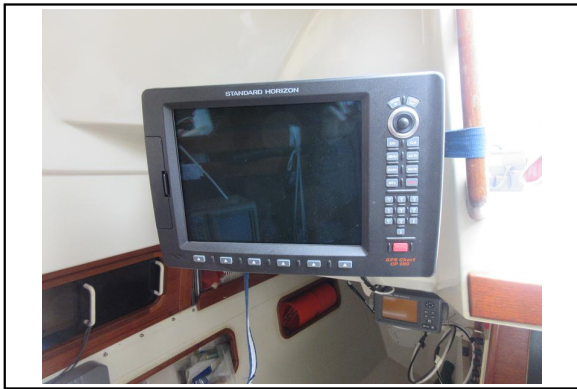
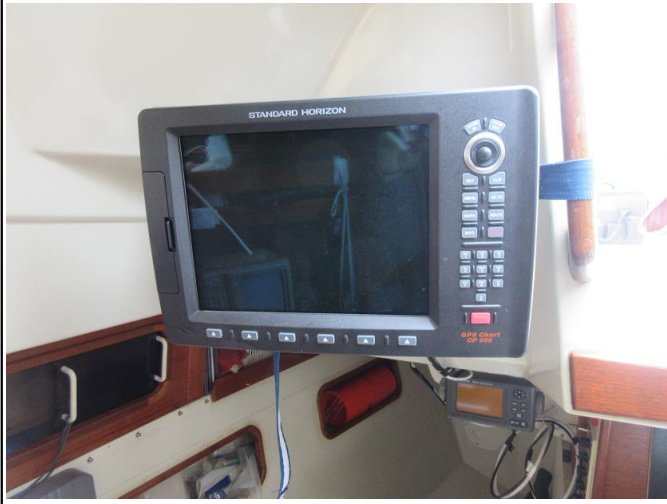
**Chart Plotter**

**CHART PLOTTER:** Lowrance Chart Plotter. model # Global Map 1000, serial # DGPS8048189.

Standard Horizon 12' Chart Plotter, model # CP590, SERIAL # 1E030010. Both systems powered up and operated.

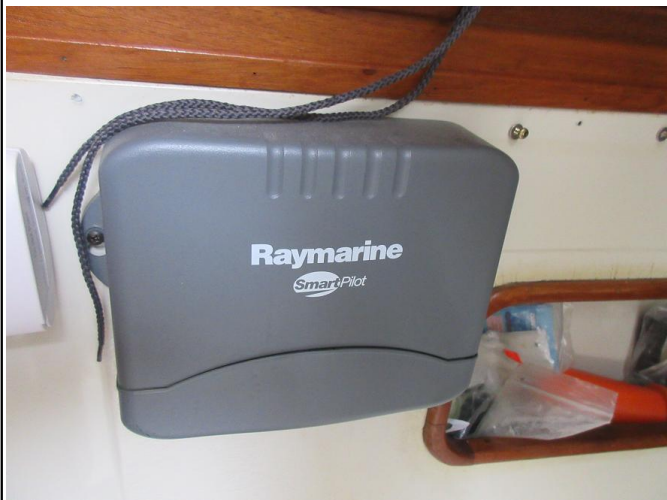
**Auto Pilot**

**AUTOPILOT:** Raymarine Autopilot, model # S100 Smart Pilot, serial # 0280308, with remote control. Powered up.
